Climate Change and Non-structural Cracks Nexus in Residential Buildings; The case of Talba Estate in Minna, Nigeria

Dukiya O. T¹., Adejumo T²., Dukiya J. S³., Dukiya J. J.^{4*}

1. Federal Road Maintenance Agency, Jos, Nigeria
2. Federal University of Technology, Minna, Nigeria,
Department of Civil Engineering
3. Federal University of Technology, Minna, Nigeria,
Department of Mechanical Engineering
4. Federal University of Technology, Minna, Nigeria,
Department of Urban and Regional Planning

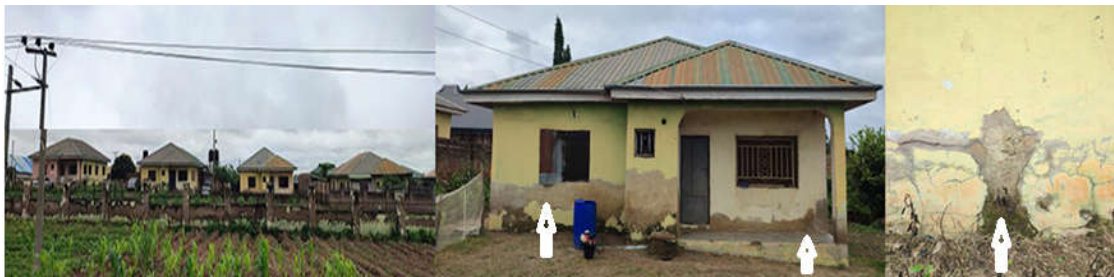
moisture ingress, and material degradation primarily at the lower part of the walls of the building. Those larger widths cracks were around the lintels, and close to ground floor slabs. Based on the crack pattern, they are mostly caused by minor settlement, contraction, foundation movement, and poor construction practices (like poor drainage system).

The study further revealed that water capillary on the building walling and efflorescence are the major challenges facing the estate. The study also finds out that there were no provisions for proper drainage system for each housing unit. The only buildings that have any form of drainage were those close to the collector road that runs through the estate. This explains why many of these buildings are plagued with moisture ingress resulting in plaster degradation and net cracks as revealed in Fig.5

Figure 5. General building defects at Talba Estate in Minna, Nigeria.
Source. Author field survey 2025

- i. Plastered Surface Cracks: Remedial procedure includes surface sealing and wall screeding with an estimated costs ranging from ₦3,600 to ₦10,800 per square meter.

- ii. Block Region Cracks: Stitching will be more appropriate for this with an estimated cost ranging from ₦18,000 to ₦36,000 per square meter.
- iii. Window lintel level cracks: Remedial procedure will involve structural reinforcement, and grouting with an estimated cost ranging from ₦25,200 to ₦54,000 per square meter.
